Seismogenic destruction of the Kamenka medieval fortress, northern Issyk-Kul region, Tien Shan (Kyrgyzstan)

Abstract

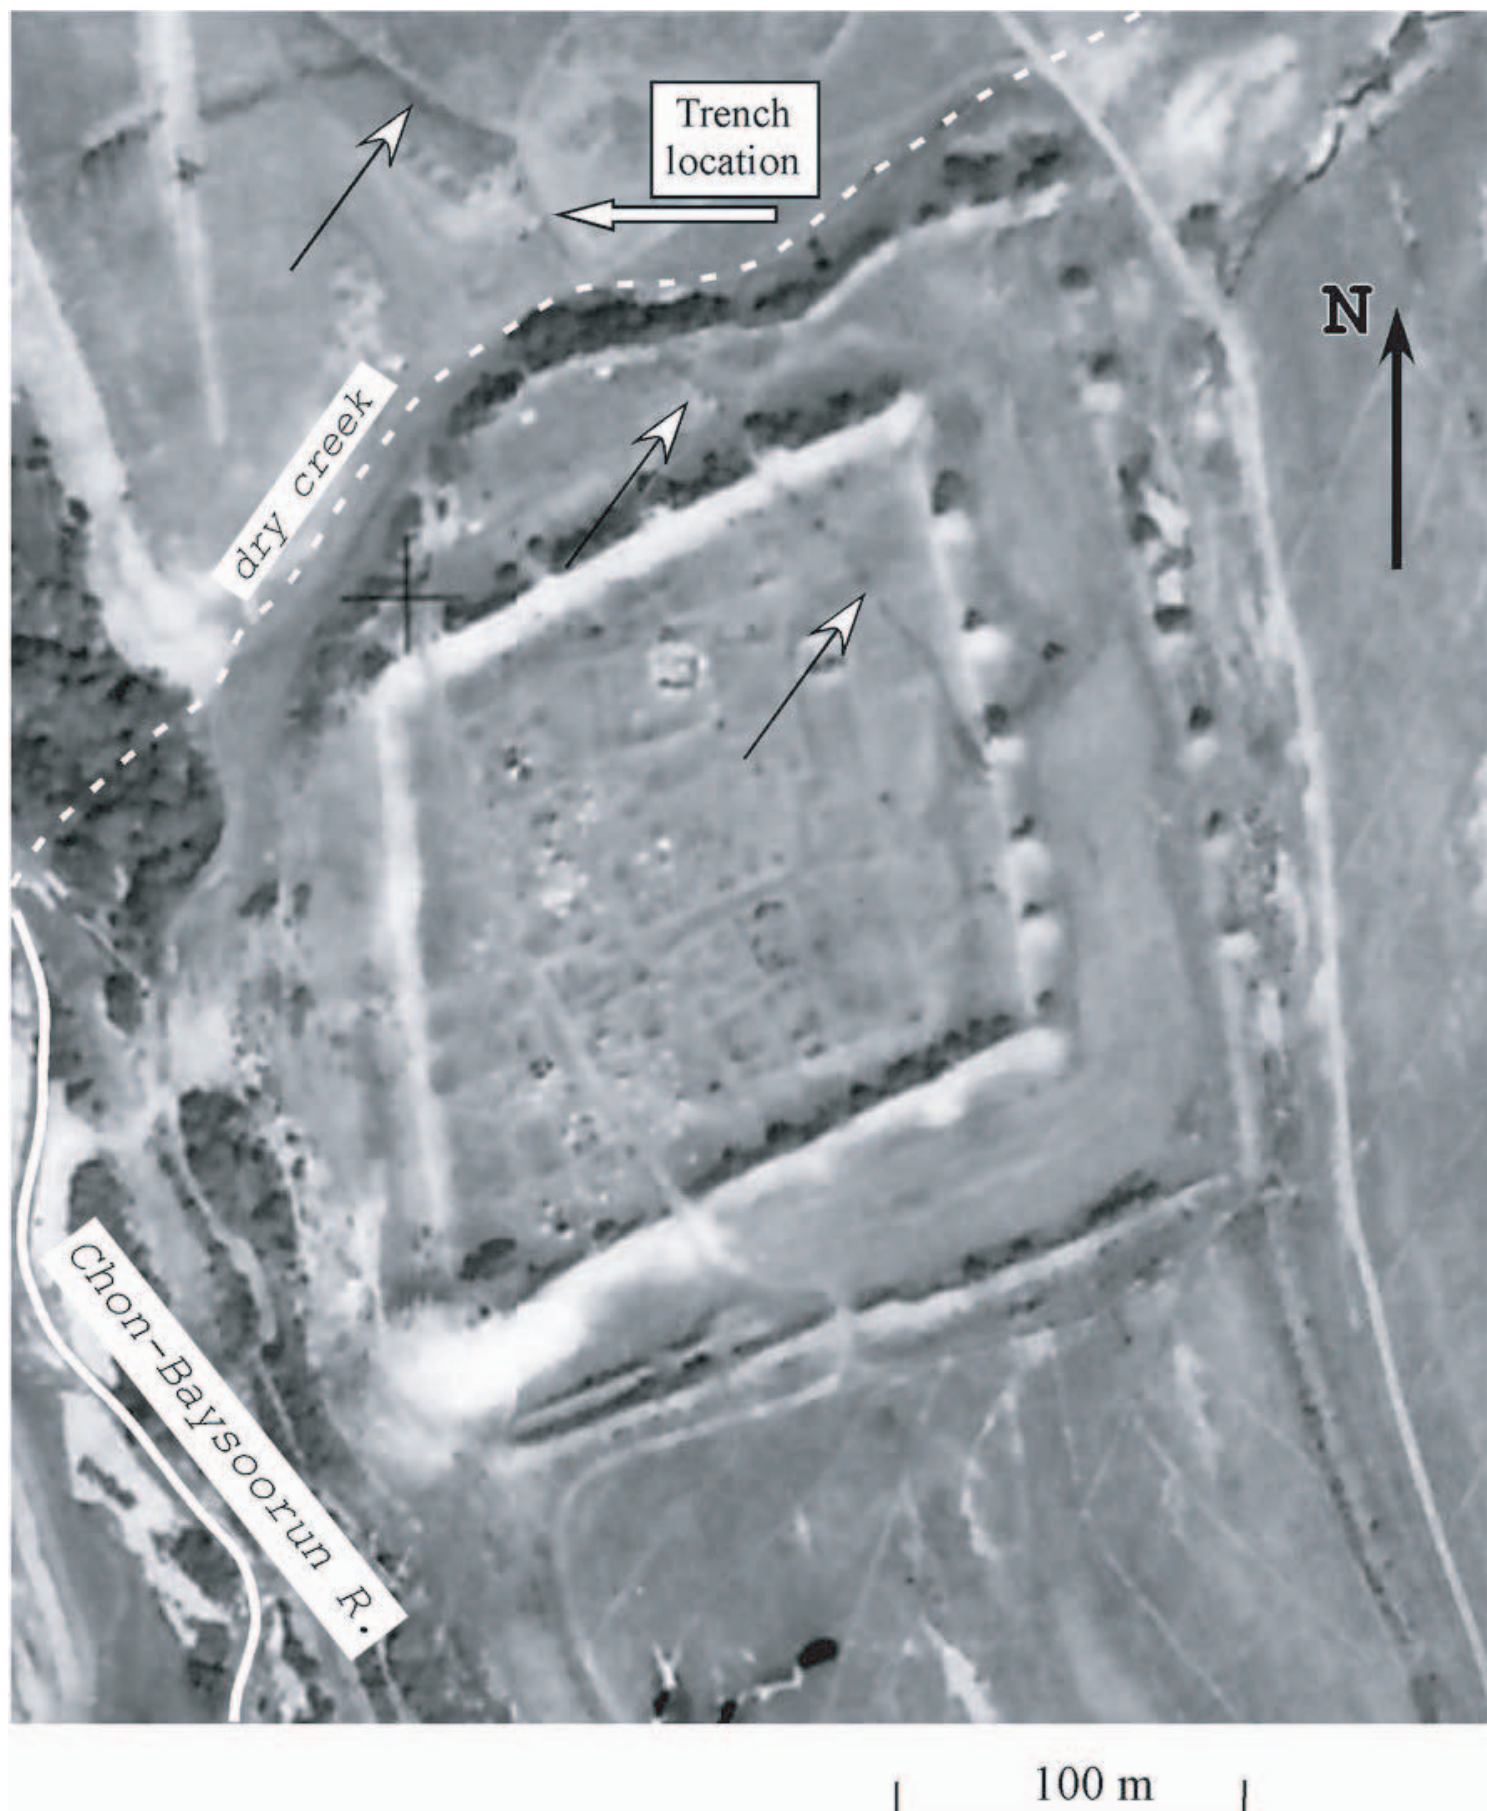
Fig. 4. Aerial photograph (scale 1:47,000) showing the Kamenka fortress and the fault scarp (shown by arrows).

We noted the Kamenka fortress during our 2004 investigation of the surface faults of the 1911 Kebin earthquake. Field investigations of the fortress were inspired by the interpretation of detailed aerial photographs of the area of this earthquake. In these aerial photographs a lineament obliquely cutting the Kamenka fortress walls is clearly visible (Fig. 4).

In order to further test our earthquake hypothesis, we excavated a trench 16 m long, up to 4 m deep and 0.8-1.0 m wide across the fault scarp at a site where the scarp cuts almost perpendicularly across the creek that destroyed the northern wall of the fortress (Fig. 4).

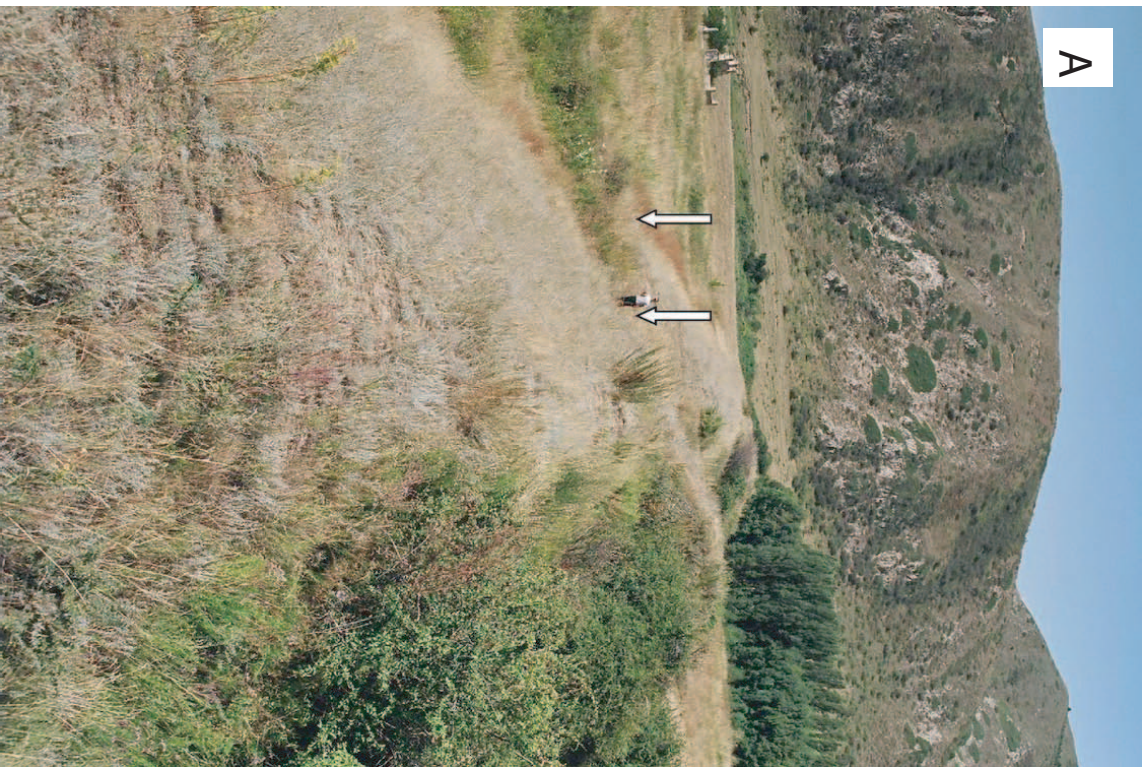
Fig. 6. Rupture in fortress walls. a) Scheme (map view) of rupture in NW wall; the wall is not only shifted laterally (left-lateral strike-slip), but also vertically (western wall marked by + is thrust upward). b) Horizontal displacement of NW internal wall on 3.85 m. c) Vertical displacement of NW external wall on 2.1 m. A man stands for scale.

In addition to vertical offset, there is also a horizontal, left-lateral, component to the displacement along the fault scarp (Fig. 6a), which is well expressed in the NW internal wall of the fortification. There, the wall is shifted to the left 3.85 m and uplifted by up to 1.6 m (Fig. 6b). Maximum vertical displacement of 2.1 m along the rupture was observed in the NW external wall (Fig. 6c).

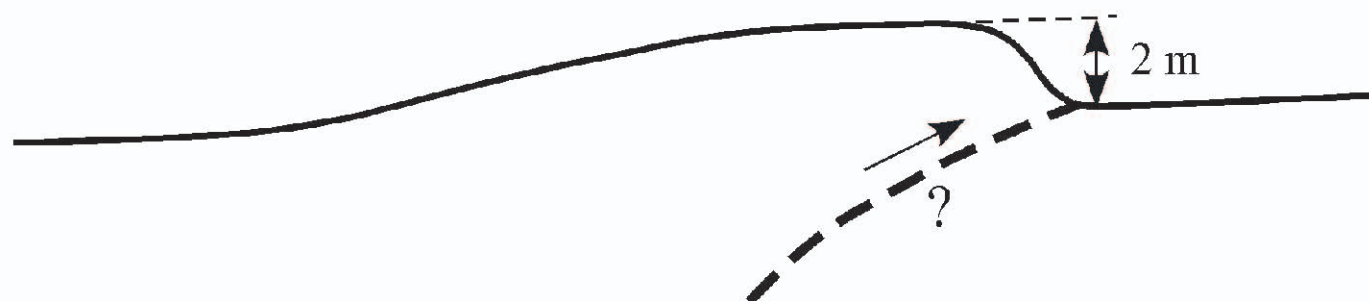
Fig. 7. Schematic section of the Kamenka fault scarp. We propose thrust movements along the fault plane because the motion on the fault is up the slope, and the scarp itself has a fold-like form typical for compression conditions.

General slope of the relief toward Chon-Baysoorun river bed

scarp

Our investigation was extended to the outskirts of the fortification. It revealed another NNW-striking fault zone parallel to the east slope of Chon-Baysoorun river valley (Fig. 5). Along this zone there were recent movements now expressed in a WSW-sloping alluvial fan by a series of fault scarps with the same trend. The 2 m tall fault scarp that cuts the fortress has an asymmetric fold-like morphology, with gentle back (SW) side rising upward into a broad flexure before breaking steeply on the frontal (NE) side. These characteristics imply a north-eastward vergence along a southwest-dipping fault plane (Fig. 7). From this observation we can conclude

that the fault scarp is of co-seismic origin (“morphogenetic earthquake” sensu Caputo, 1993) and corresponds to an oblique thrust fault.

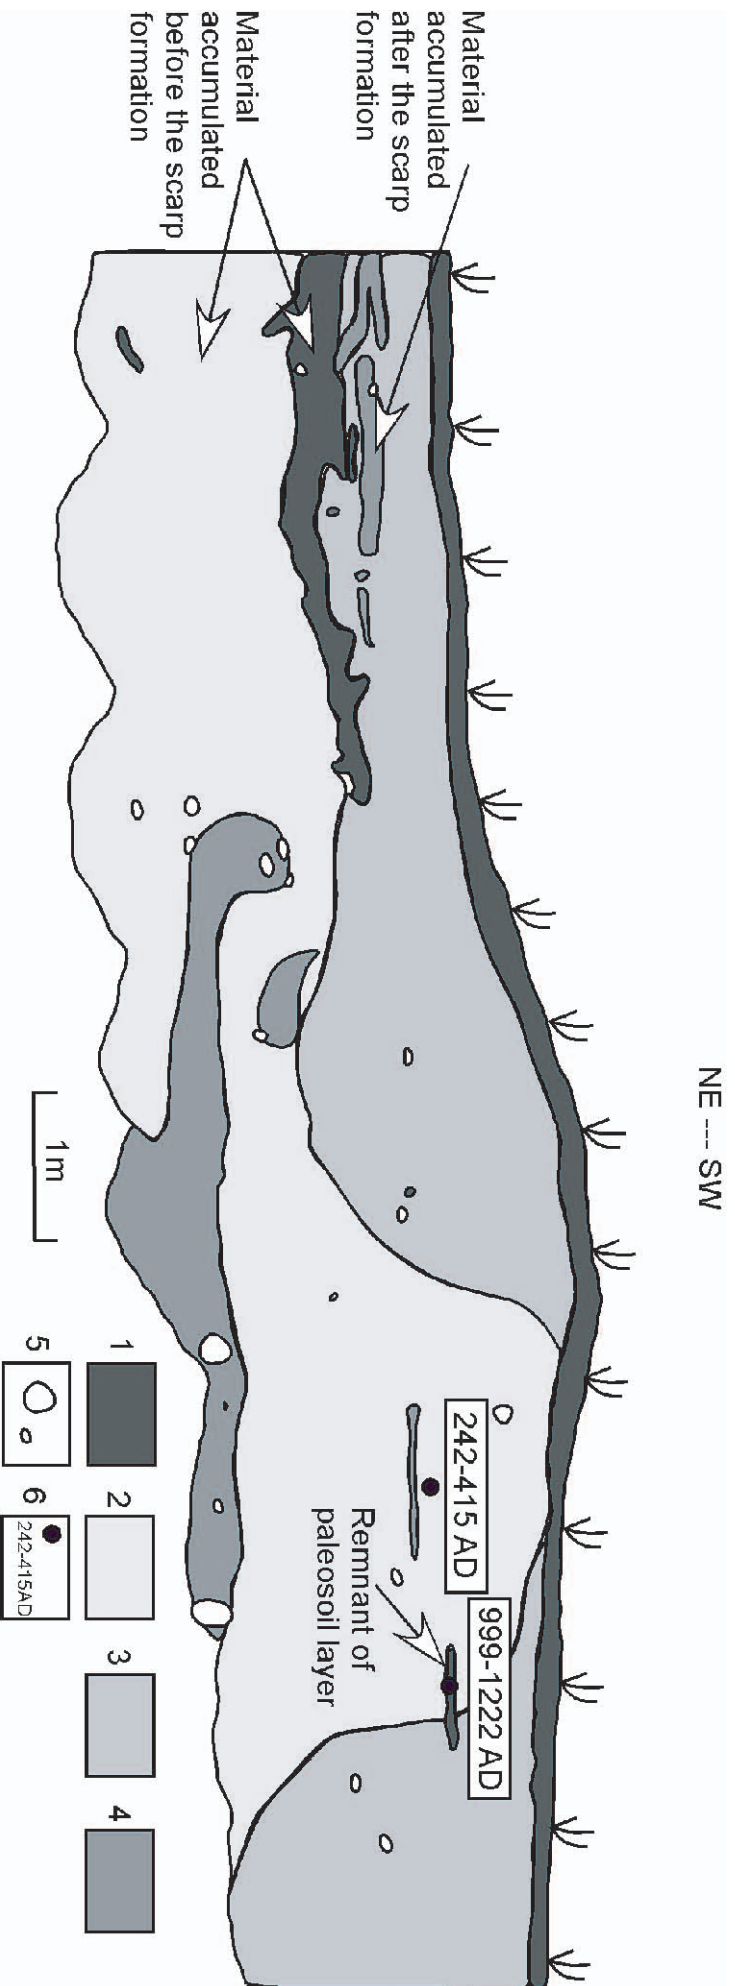
Fig. 8. A log of southern wall of the paleoseismic trench excavated across the fault scarp.
1 - soil layers, 2 - clay, 3 - loam, 4 – coarse sand, 5 - cobbles, 6 - places of sample collection.

The main characteristics of the sediments exposed in the trench are thick units of clay and loam (loess-like deposits), capped by a layer of undisturbed soil. We noted a buried soil in the eastern third of the exposure that likely represents a paleo-ground surface. The soil is also present on the hanging wall of the fault but is less well preserved. Associated with the paleosoil in the hanging wall is a horizon of crushed and broken bones. Above the paleosoil in the footwall there is a lens of well-sorted coarse sand. Pebble-sized clasts of Paleozoic-aged rocks are disseminated through the units and do not define any bedding. The recent soil covers the entire exposure.

In the NE part of the trench, the units described above are warped in a zone of distributed deformation (fractured and sheared sediments). We could not identify clear co-seismic rupture with confidence because of the homogeneous stratigraphy and distributed nature of the deformation. The western end of the buried soil in the eastern third of the exposure is strongly deformed where it enters the zone of distributed deformation. A lens of well-sorted coarse sand above the paleosoil does not cross the deformation zone and is likely colluvial material that has been shed from the scarp formed during the most recent earthquake. Preferential preservation of the paleosoil can be explained by stripping of the paleosoil horizon from the hanging wall of the fault and by colluvial sedimentation of coarse sand on top of the paleosoil in the footwall.

not find bone fragments above this horizon. We collected samples from the top and bottom of the bone layer for determination of the absolute age using the ^{14}C method (Fig. 8). Dating was conducted at the Laboratory of Geology and Paleoclimatology of the Cenozoic at the Institute of Geology of Siberian Branch of the Russian Academy of Sciences in Novosibirsk. Determination of the radiocarbon age was done using the standard conventional method on the humic acid fraction.
